INDOOR AIR QUALITY ASSESSMENT

**North Quincy High School
316 Hancock Street
Quincy, Massachusetts**

Prepared by:
Massachusetts Department of Public Health
Bureau of Environmental Health Assessment
August 2002

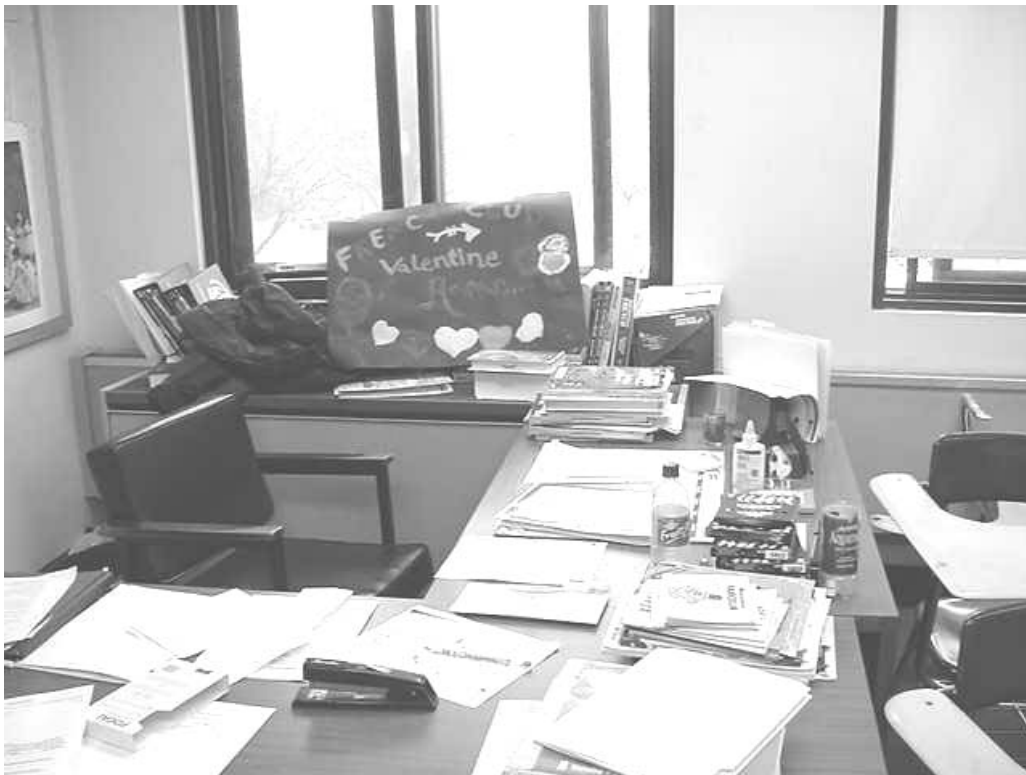
Picture 1

Classroom Univent Obstructed by Items on top of Air Diffuser and in Front of Univent Return

4. Inspect exhaust motors and belts for proper function, repair and replace as necessary.
5. Remove all blockages from univents and exhaust vents.
6. Once both the fresh air supply and exhaust ventilation are functioning, the ventilation system should be balanced.

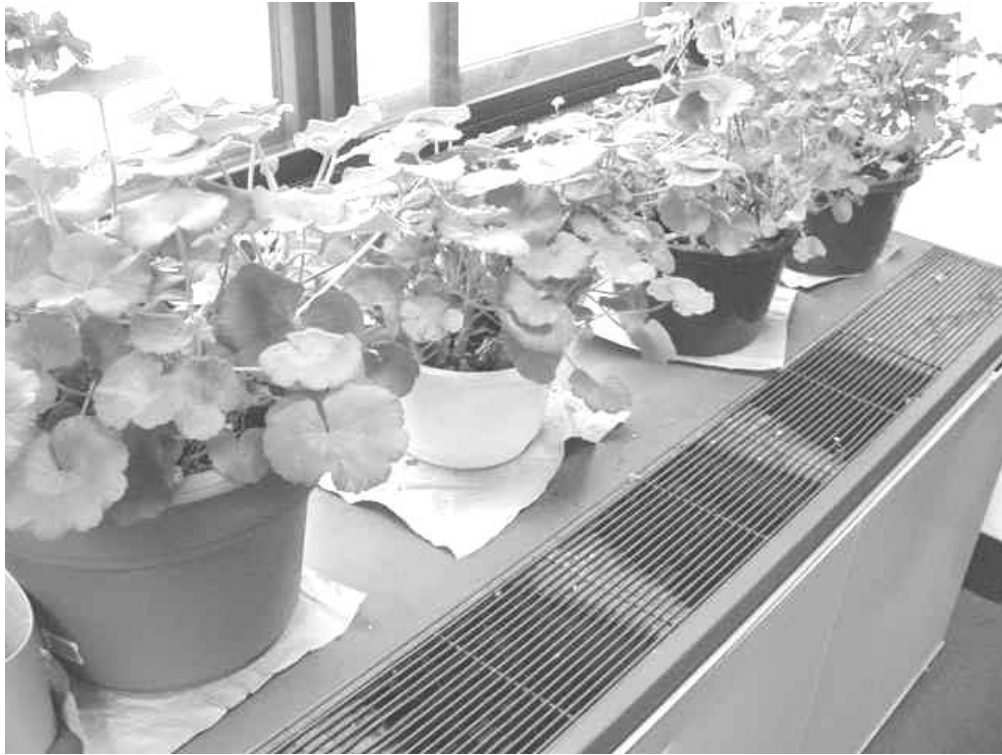
Picture 2

Plants on Top of Univent in Close Proximity to Air Diffusers, Also Note Plants on Top of Paper Towels

9. Move plants away from univents in classrooms. Examine drip pans for mold growth and disinfect areas of water leaks with an appropriate antimicrobial where necessary.

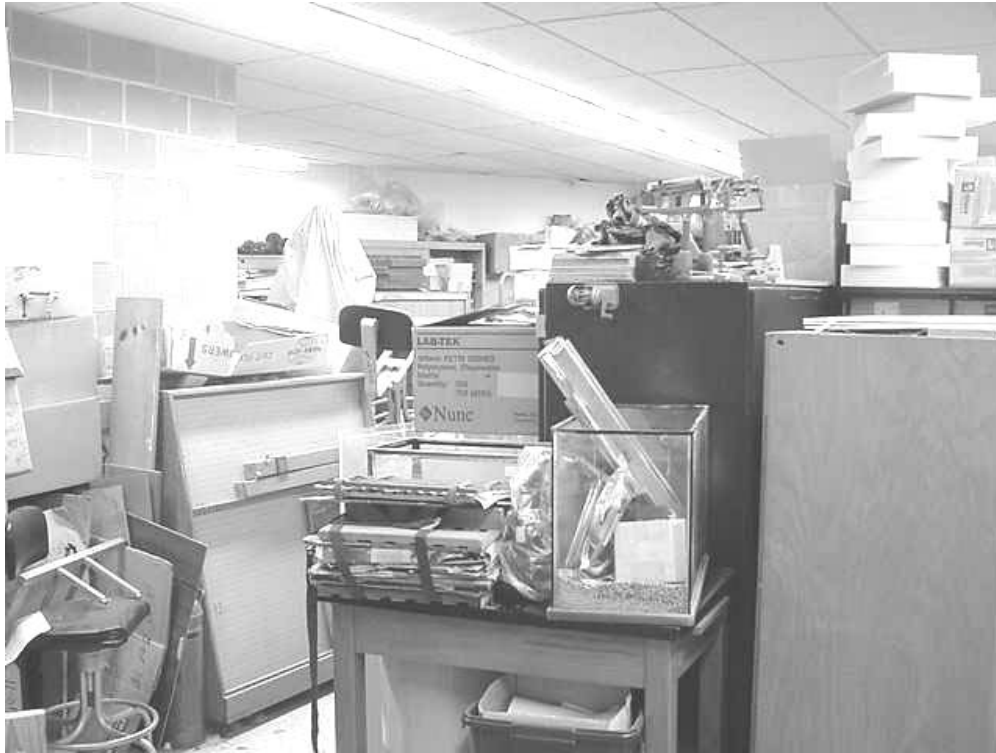
Picture 3

Accumulated Items in Science Storeroom

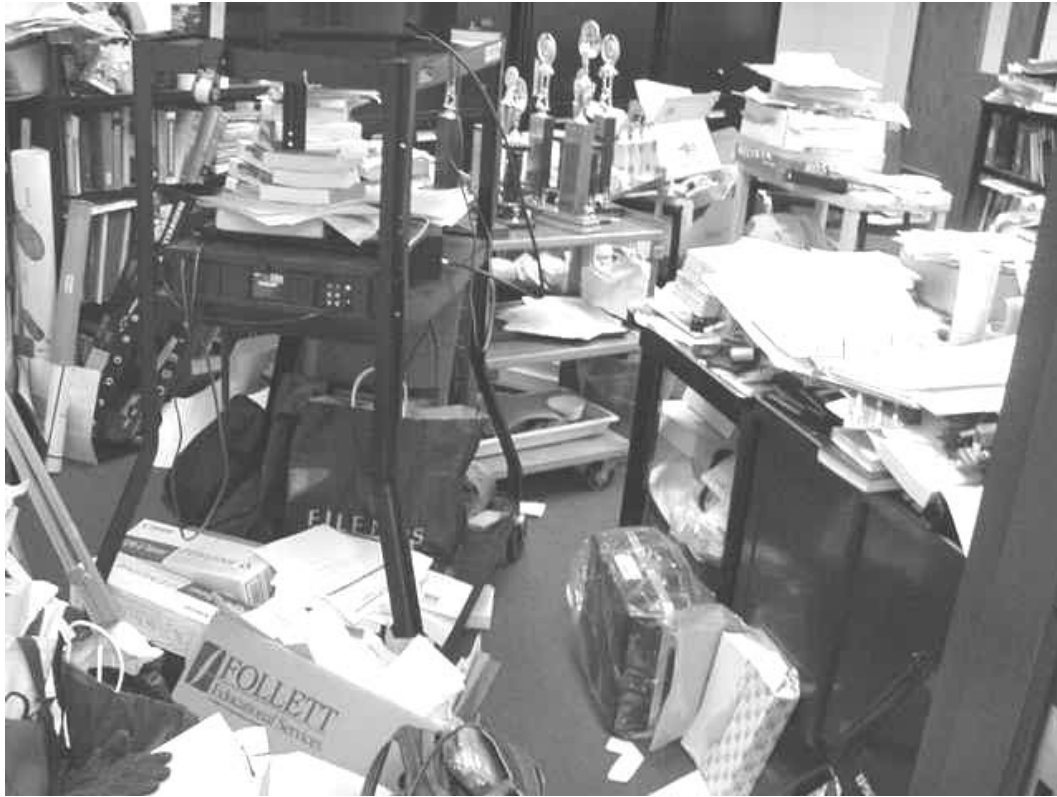
Picture 4

Accumulated Items in Science Office

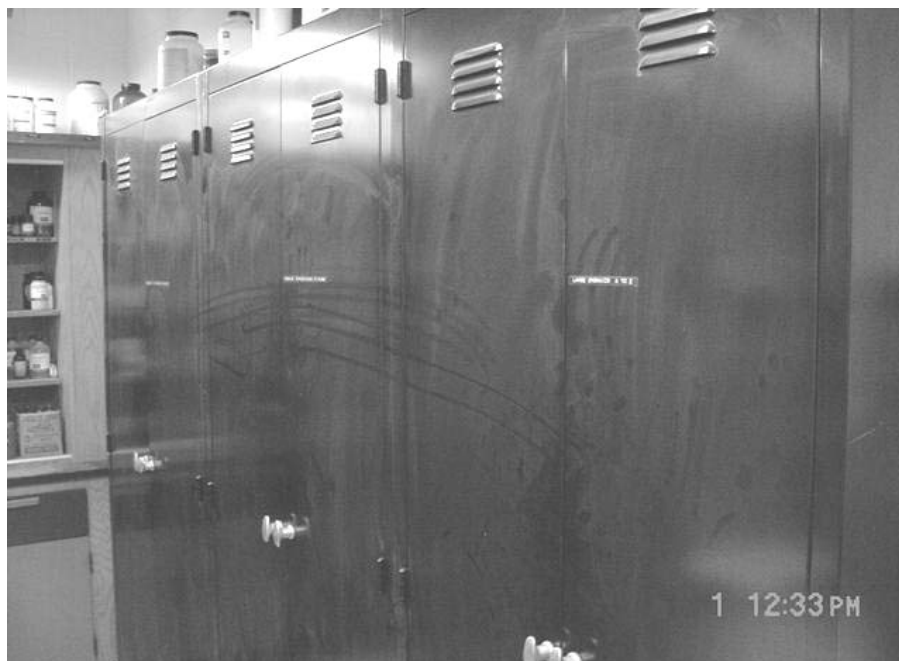
Picture 5

- The three metal storage cabinets are not flammable storage cabinets. The doors of these cabinets can allow air to pass into the cabinet interior to provide an oxygen source to support combustion. The shelves have begun to corrode from exposure to off-gassing chemicals (see Picture 11). A number of flammable VOCs (see Tables 22 through 24) are stored in these cabinets. Exposure to vapors of off-gassing chemicals can be irritating to the eyes, nose and respiratory system. In addition, flammable materials should be stored in a cabinet that meets the requirements of the National Fire Prevention Association (NFPA) (NFPA, 1996). With this breach, it would not be expected that this cabinet would perform to prevent fire spread to stored chemicals.

Metal Storage Cabinets

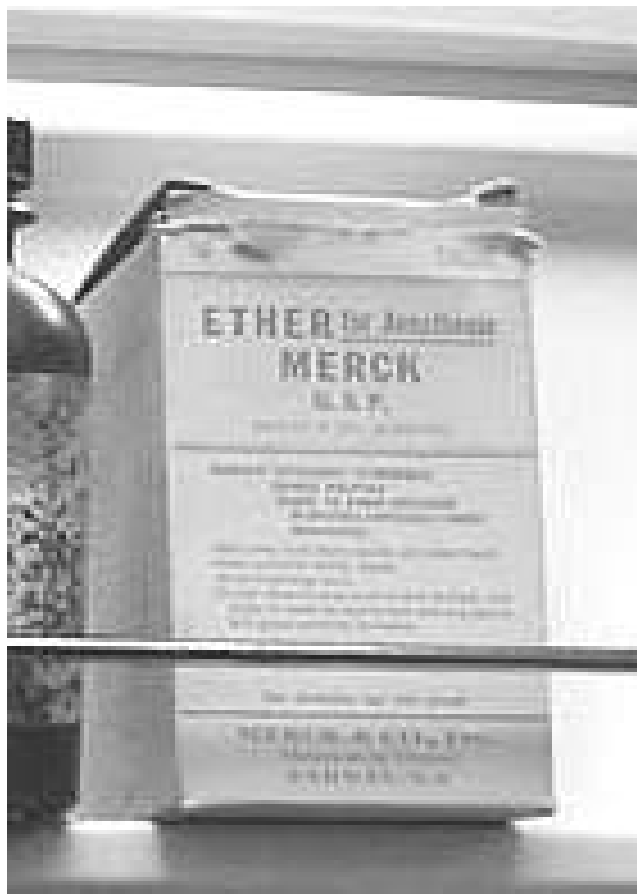
Picture 6

Ethyl Ether on Door of Refrigerator in Storeroom

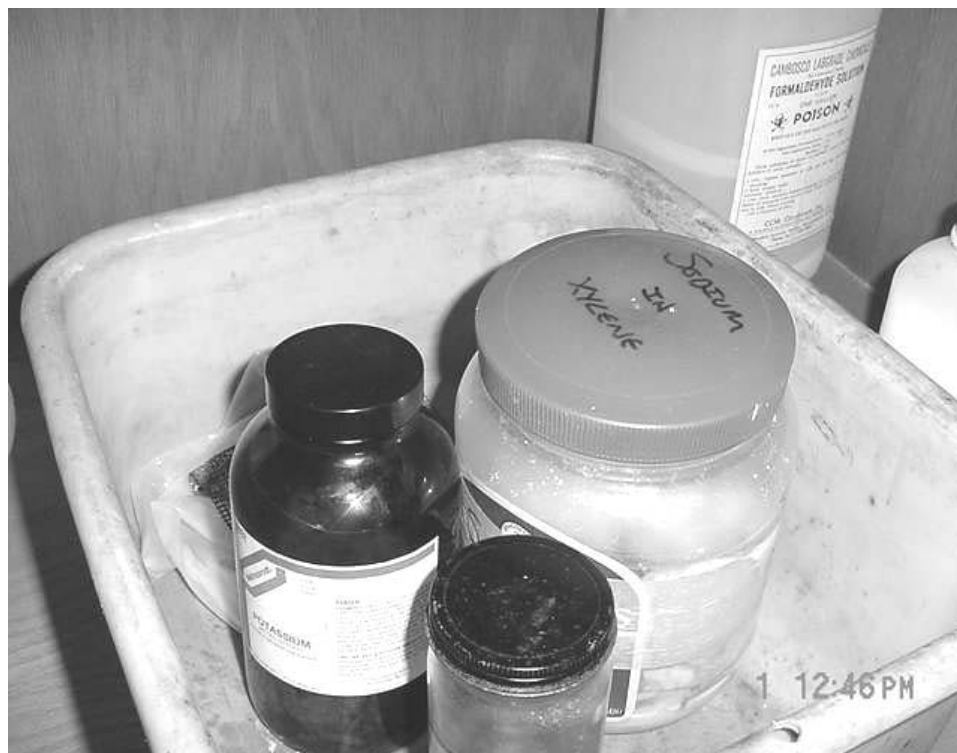
Picture 7

Container Labeled "Sodium in Xylene", Note Bulge in Lid

1. Remove sodium metal from plastic container and place in a container that is VOC degradation resistant.
2. To maximize air exchange, the BEHA recommends that both supply and exhaust ventilation operate continuously during periods of school occupancy independent of classroom thermostat control.
3. Examine each univent for function. Survey classrooms for univent function to ascertain if an adequate air supply exists for each room. Operate fresh air supply univents while classrooms are occupied. Consider consulting a heating, ventilation

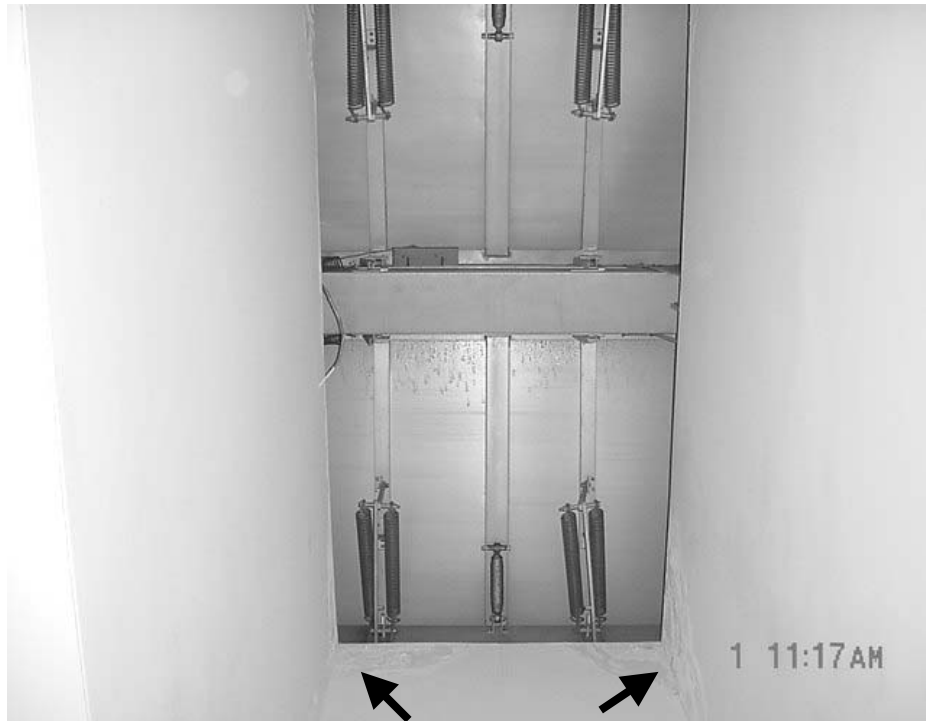
Picture 8

**Pressure Relief Louver In Skylight Above Cabinet Containing Water Reactive Materials
Note Stain on Louvers and Damaged Plaster, Indicating Historic Water Leaks**

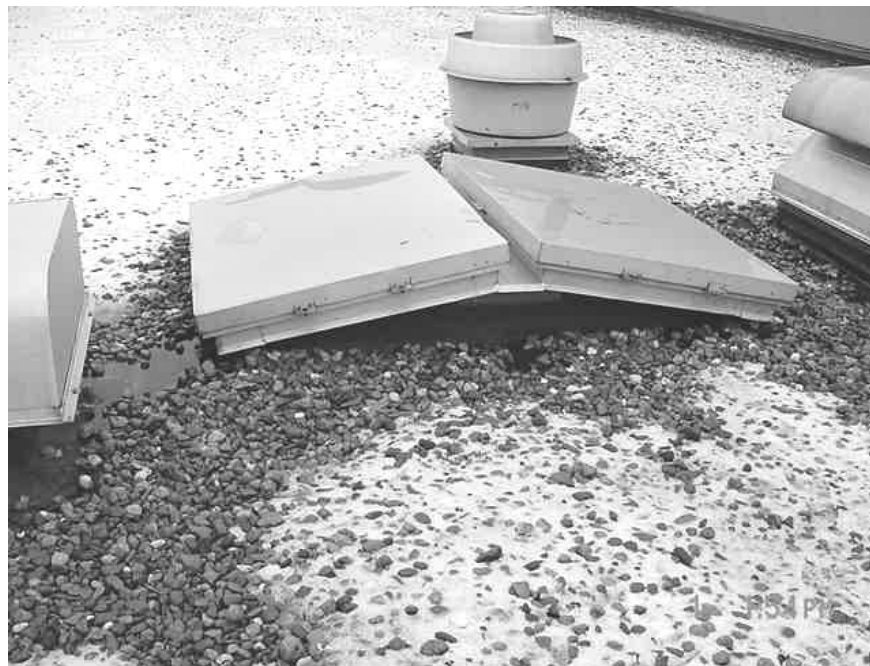
Picture 9

**Pressure Relief Louver In Skylight Above Cabinet Containing Water Reactive Materials
View On Roof**

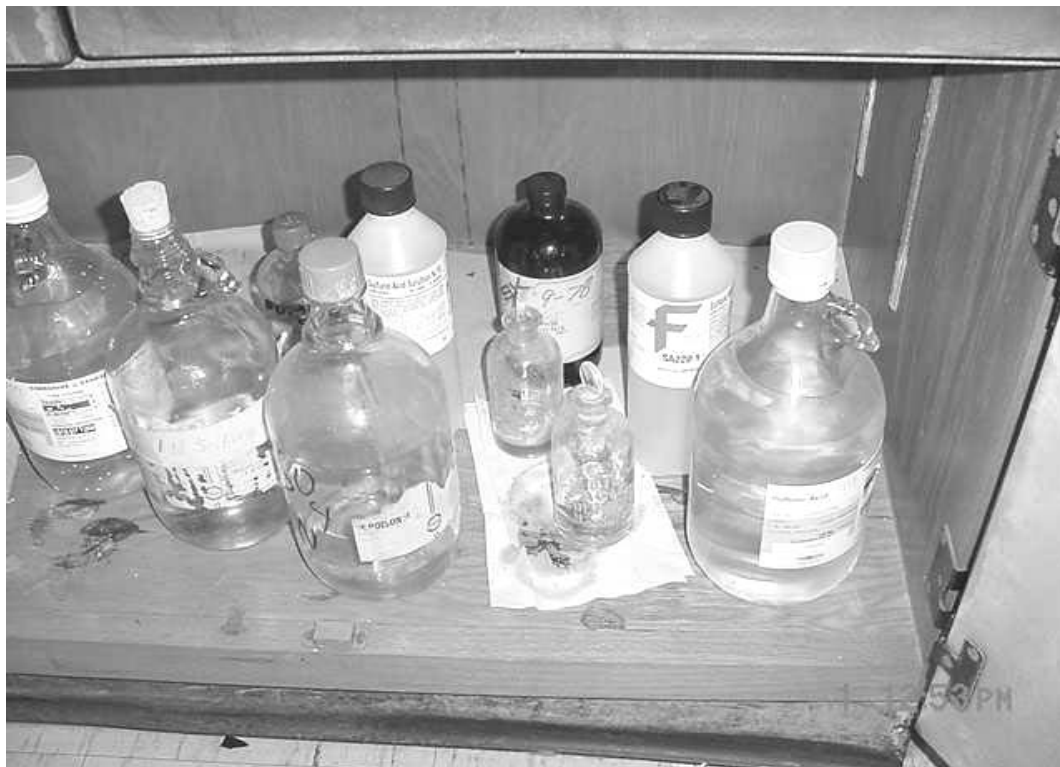
Picture 10

- On the opposite side of the back wall of the cabinet containing the water reactive materials are stored acids (see Picture 10). Acids are diluted in water to reduce concentration. The caps for several of these containers are corroded, indicating acid

Acids Stored In Same Unit As Water Reactive Materials, Note Crystallization On Caps And Corrosion Of Metal Hinges

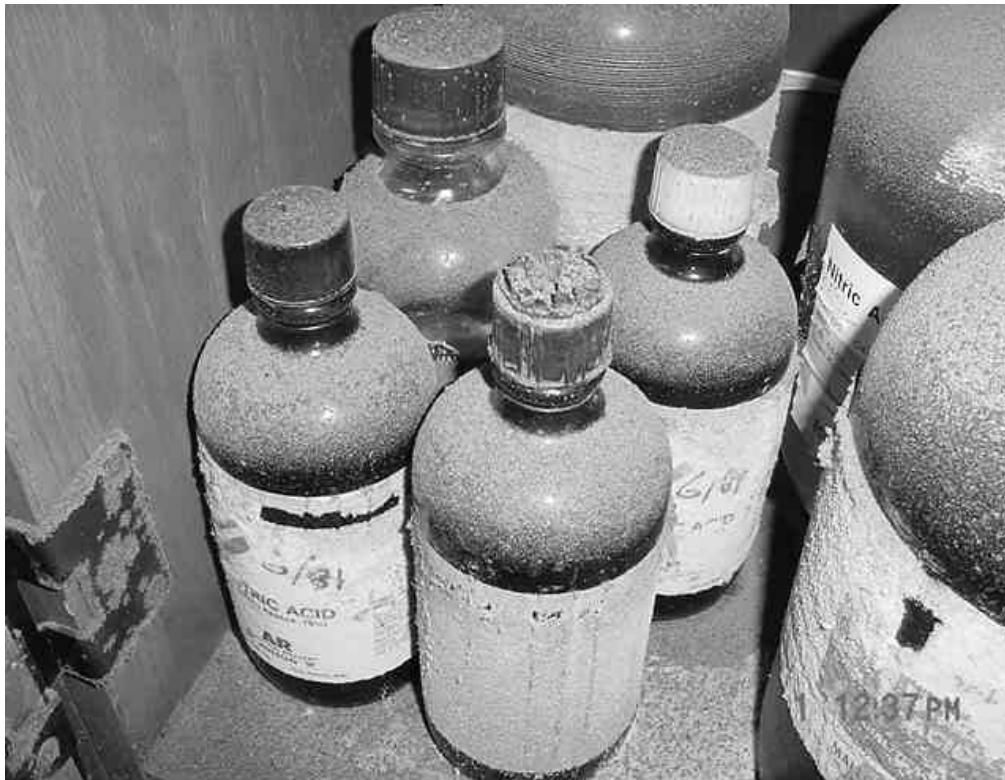
Picture 11

- Acids were stored in the wall-mounted wood unit cabinet. Acid containers were heavily coated with rust, indicating significant material degradation of metal cabinet components and/or metal containers in this cabinet. Corresponding damage was noted on cabinet latches and hinges. Substantial corrosion to the latches and shelf supports indicate that acids are off-gassing from containers. In order to prevent metal corrosion, acids should be stored in acid proof cabinets.

Corrosion of Metal Components of Cabinet, Note Heavy Coating Of Bottles with Rust Particles

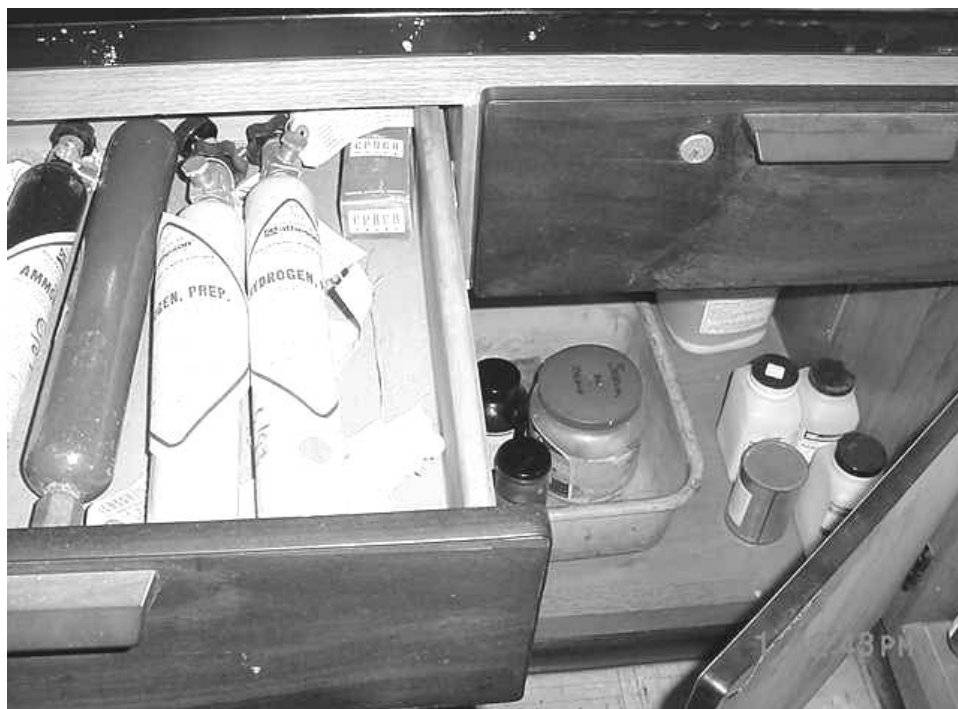
Picture 12

- Gas cylinders of hydrogen, ammonia and chlorine were found stored in a drawer above the “sodium in xylene” cabinet (see Picture 12). Under both industry regulations and good chemical storage practice standards, cylinders of compressed gas must be fixed to a wall or stand to prevent damage to cylinder valves by tipping (Rose, S. L., 1984). A damaged cylinder valve can cause an immediate and uncontrolled release of the cylinder contents and result in the cylinder becoming a projectile. These cylinders must be secured as soon as possible to prevent accidental release and injury.

Gas Cylinders Stored In Drawer Above “Sodium In Xylene” Container

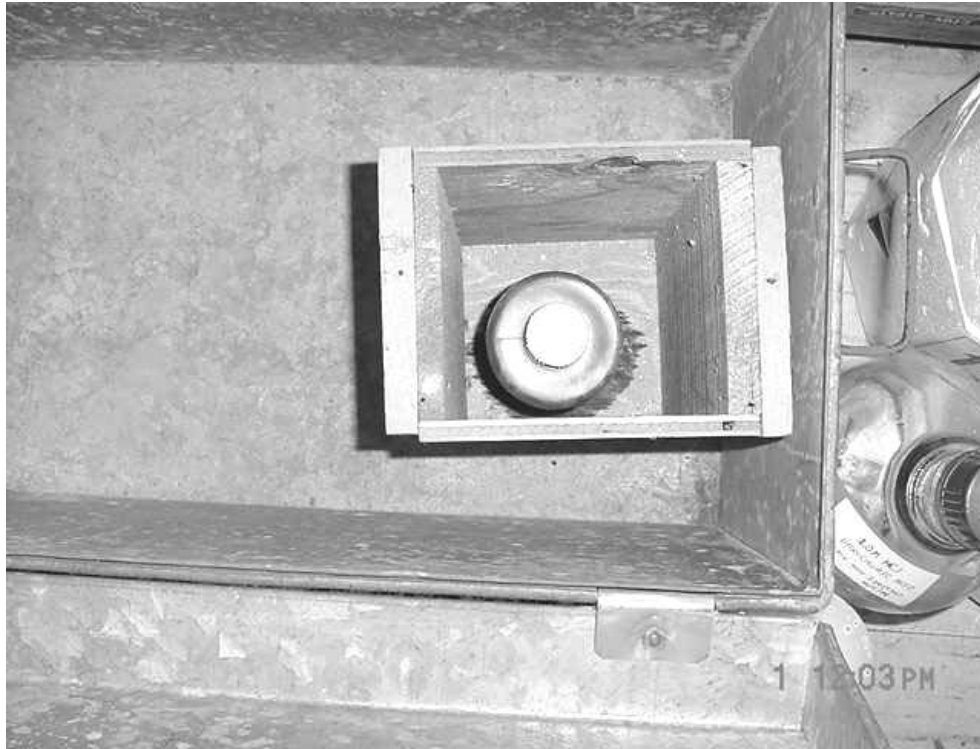
Picture 14

- A metal container below the refrigerator contains a bottle within a wooden box (see Picture 14). The product appears to have leaked from this container, which was reported as containing perchloroacetic acid by NQHS staff.

**Metal Container below the Refrigerator Contains A Bottle within A Wooden Box
Note Stain**

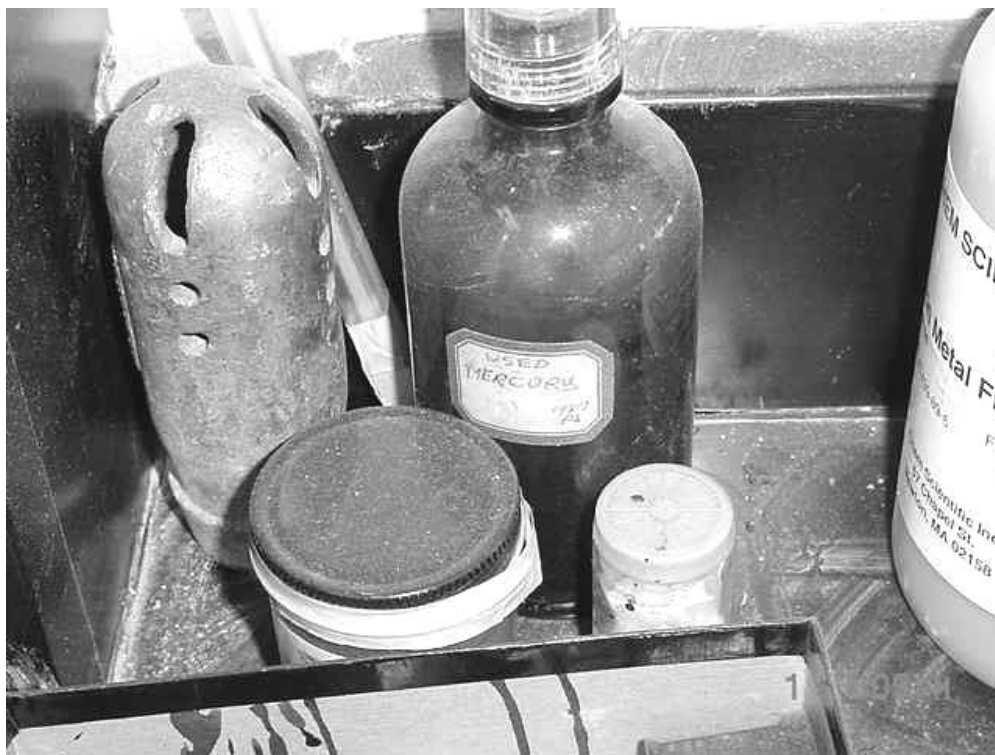
Picture 15

Elemental Mercury in Jar near Sink

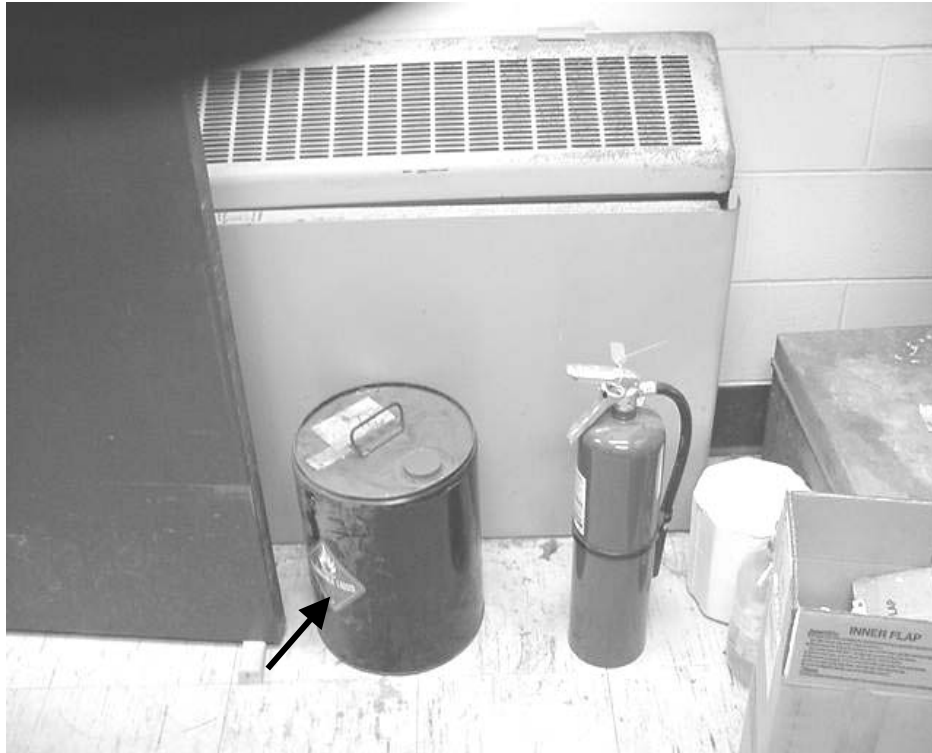
Picture 16

**A Container Marked Flammable Is Stored Next To A Radiator,
Note Flammable Label**

11. Store cleaning products properly and out of reach of students. Store flammables in a flameproof cabinet.
12. Replace missing ceiling tiles, to prevent the egress of dirt, dust and particulate matter into classrooms.
